**VEHICLE AND SURVIVAL FACTORS ATTACHMENT 5 – MOUNTAIN VIEW FD
SAFETY ALERT**

HWY18FH011

MEMORANDUM#43-18

SUBJECT: Safety Alert – Electric Vehicles High-Voltage Battery Fire

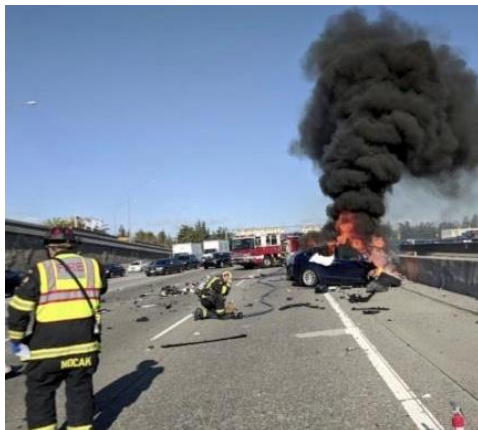
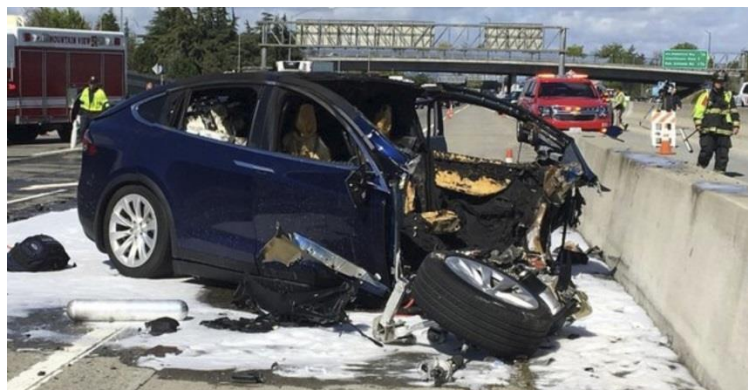
On March 23, 2018, the Mountain View Fire Department responded to a MVA SB101 at Highway 85 involving three vehicles. One of the vehicles involved was an electric vehicle (EV), a Tesla Model X. On the arrival of E55, the electric vehicle's 400-volt battery pack had significant intrusion due to the collision, it was clearly damaged, and it was also on fire. The driver, the single occupant of the Model X, had been extricated by other motorists and was unconscious. There were no other victims. E53 and E55 personnel rendered care and extinguished the vehicle and battery fire with approximately 200 gallons of water. It was noted that full extinguishment of the EV occurred within two minutes. Water application to the exposed battery pack was stopped after approximately 10 minutes of being on scene due to no obvious signs of fire in the battery. The critically injured driver was transported to Stanford Hospital Trauma Center in the care of two MVFD Firefighter Paramedics. The patient, despite efforts, later succumbed to his injuries in the ER.

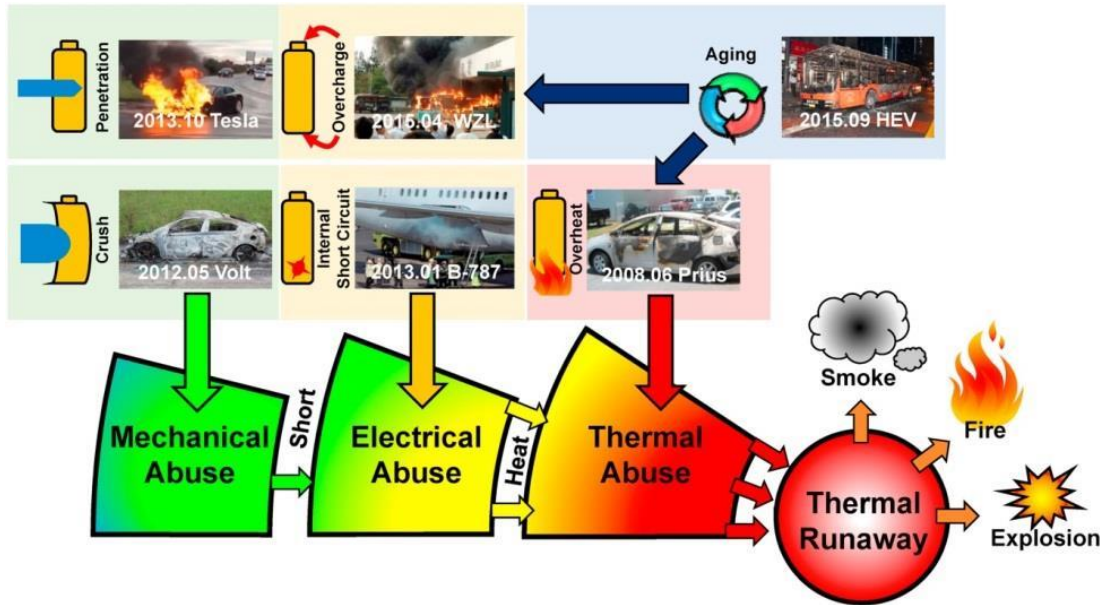
Examples of Lithium-ion thermal runaway fires

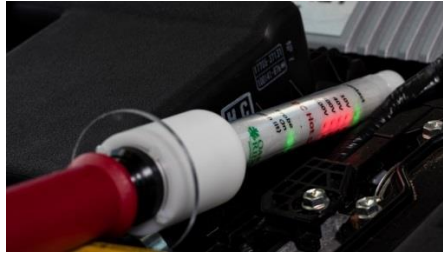
DC Hot Stick prototype being developed by the U.S. Department of Energy

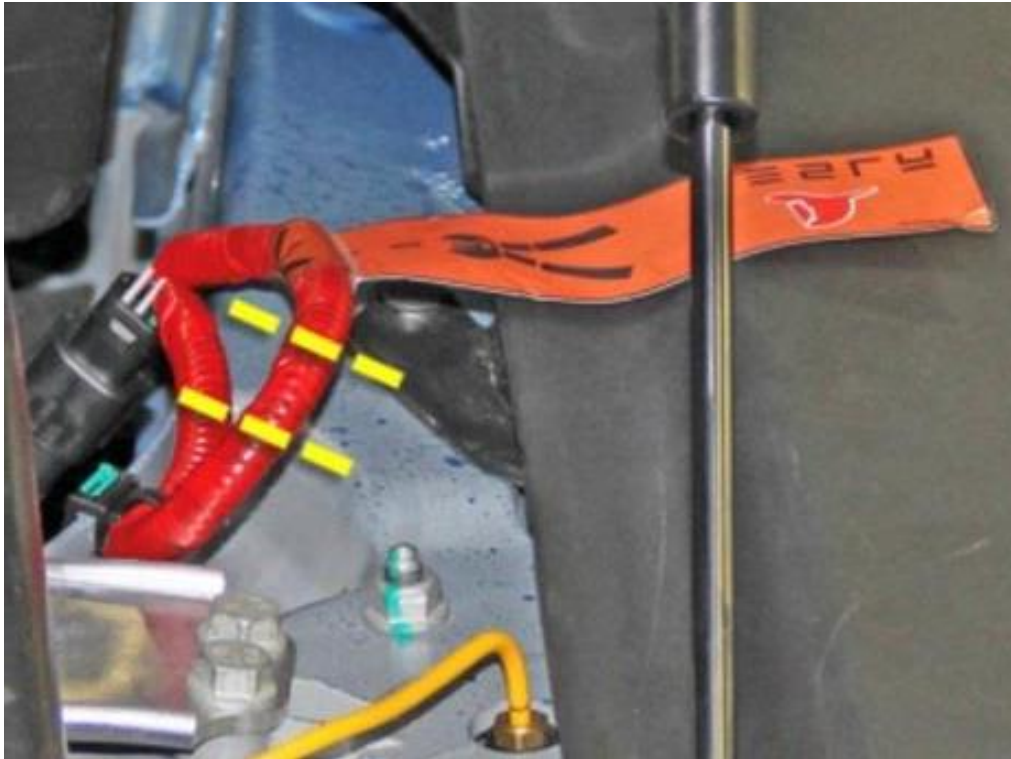
NOTE: In this accident and fire in Mountain View, the “First Responder Loop,” (which is the low-voltage harness made available to shut down the high voltage system in a Tesla), was destroyed on impact and, thus, Firefighters were not able to disconnect the high-voltage battery. However, even if we had access to cut the “First Responder Loop” we would still have the extinguishment challenge of a damaged battery and its thermal runaway event.
